# ROOF INSPECTION GLASGOW

Roof Survey Report

Property address	XX XXXXX XXXXXX XXXXXX
Customer	XXXXXX XXXXX
Intent	Roof survey of city tenement ahead of purchase to evaluate current condition of the pitched and flat roofs, cupola, chimneys and rainwater fittings noting repair works and costs.
Prepared by	XXXXXXXX XXXXXXXX
Date of inspection	XX XXXXXX XXXX

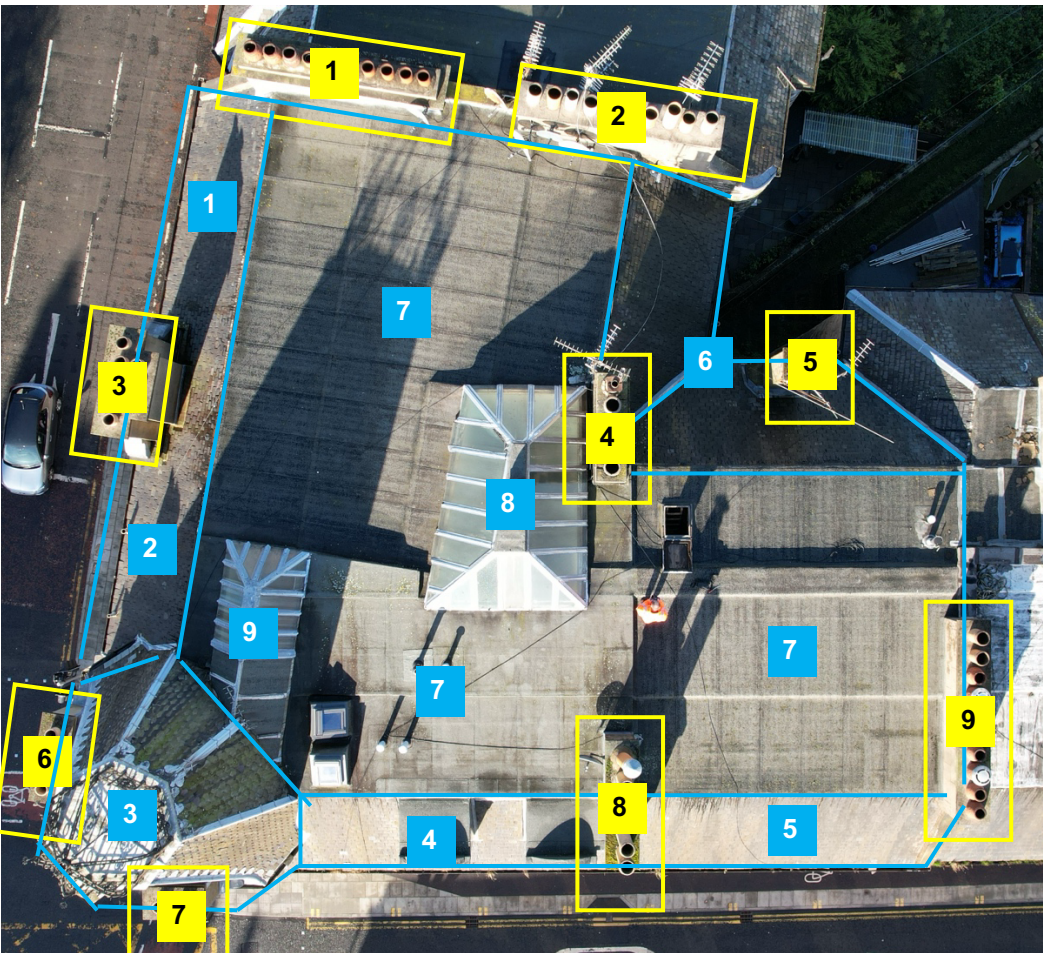
Overview	
<b>Notes</b>	Overview of flat and pitched roof sections (blue) and chimneys (yellow) for review.
<b>Evidence</b>

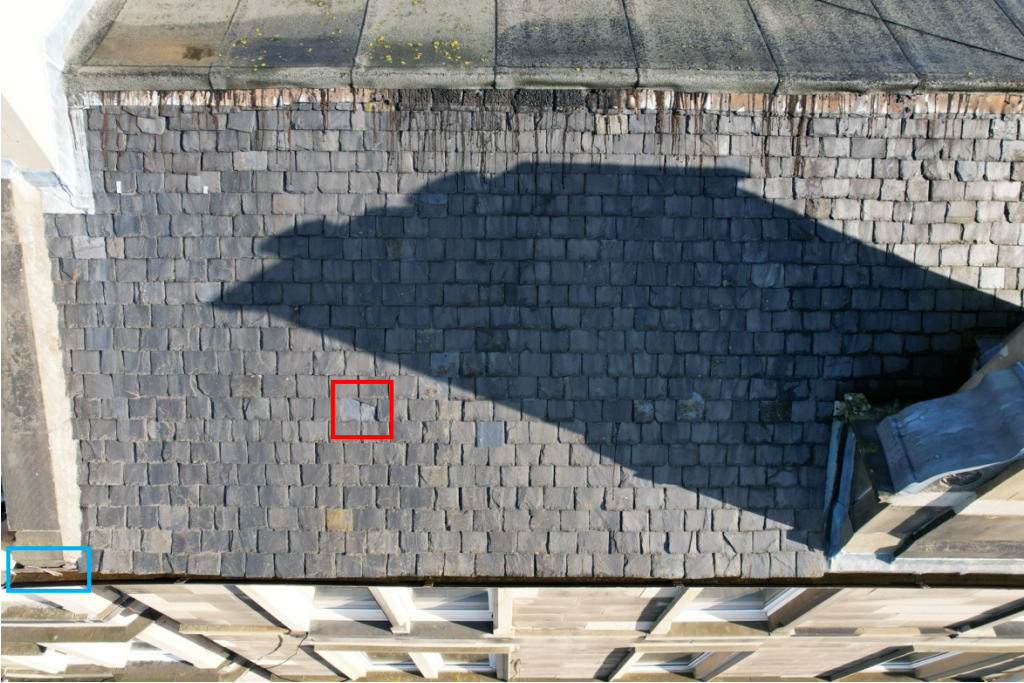
Section 1	
Repair Cat	2
Notes	<p>Pitched Scottish slate tiled roof with cement skew.</p> <p>Major: broken tile (marked red),</p> <p>Minor: missing pointing at base of coping (marked blue).</p>
Evidence

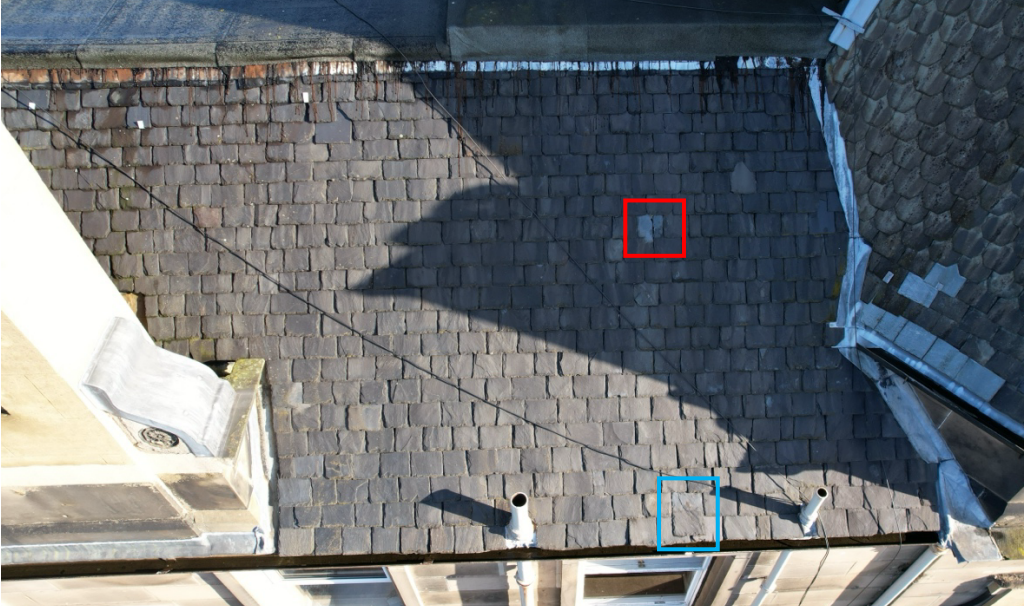
Section 2	
Repair Cat	2
Notes	Major: missing tile (marked red), Minor: slipped tile (marked blue).
Evidence

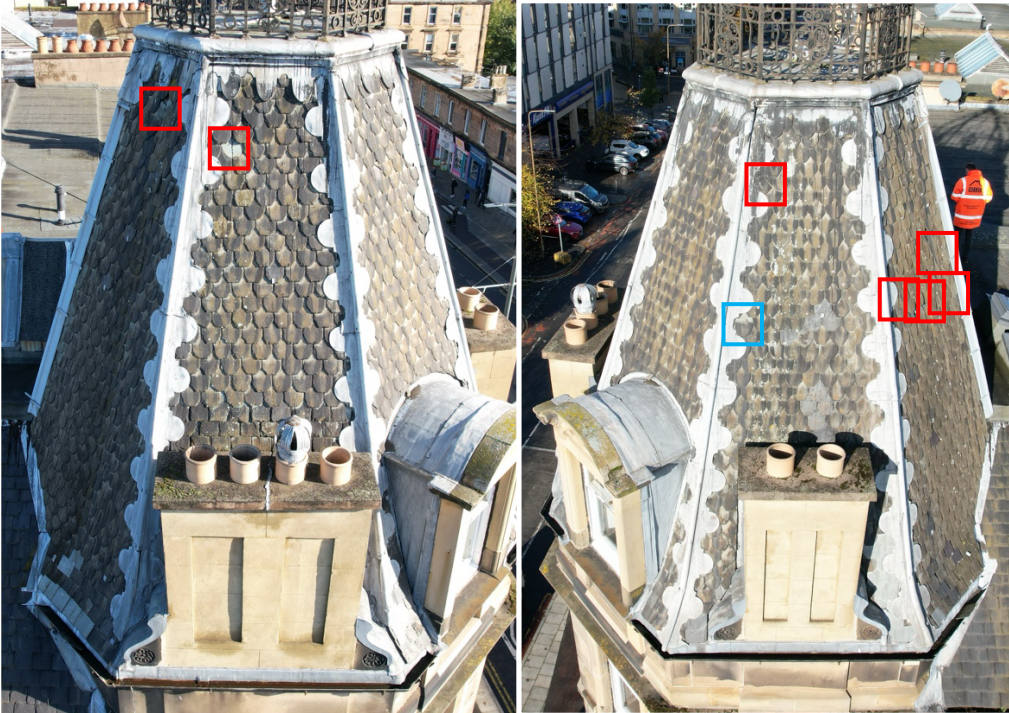
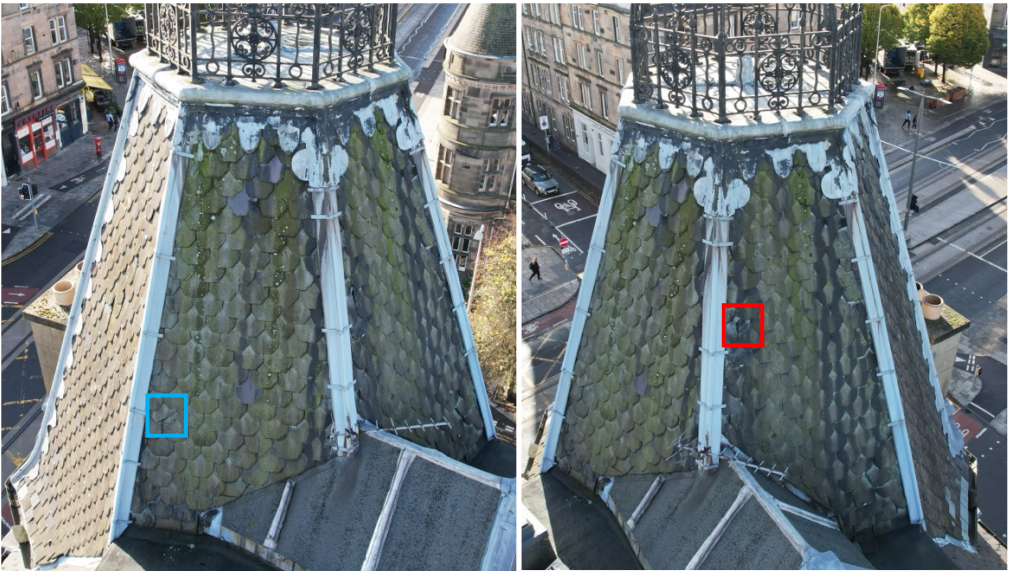
Section 3	
Repair Cat	2
Notes	<p>Helm roof with slate pitches with lead and zinc flashing and dormer window.</p> <p>Major: missing tiles (marked red),</p> <p>Minor: slipped tiles (marked blue).</p>
Evidence

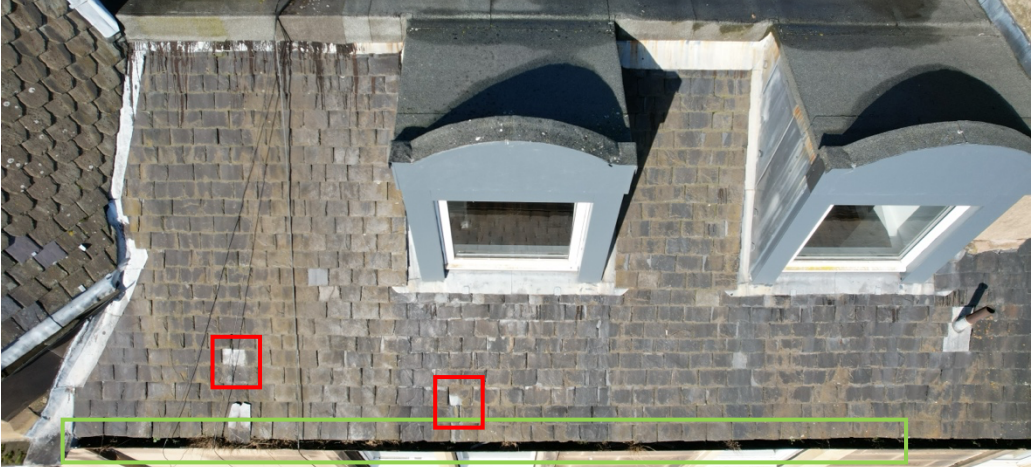
Section 4	
Repair Cat	2
Notes	<p>Pitched Scottish slate tiled roof with two dormer windows.</p> <p>Major: missing or broken tiles (marked red),</p> <p>Minor: gutters require cleaning (marked green).</p>
Evidence

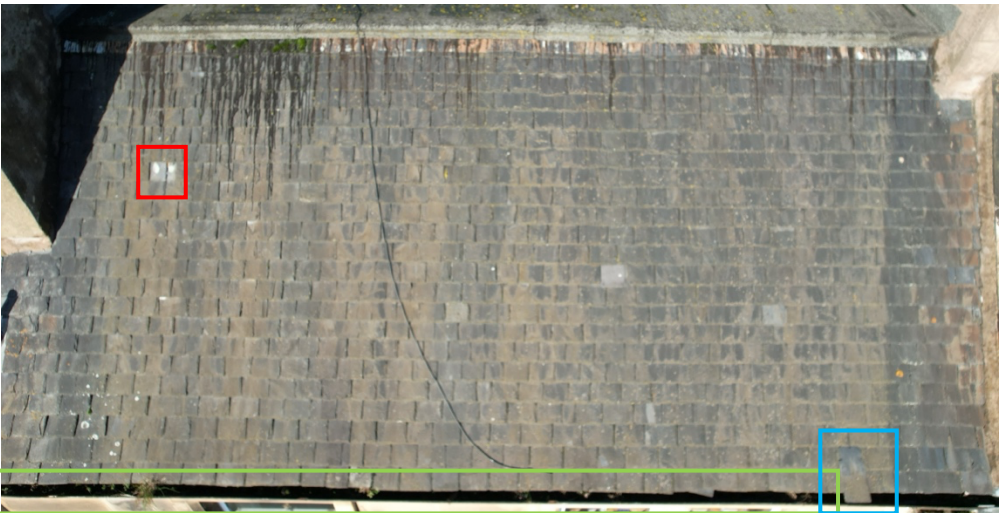
Section 5	
Repair Cat	2
Notes	<p>Major: missing (marked red),</p> <p>Minor: slipped tile (marked blue), gutters require cleaning (marked green).</p>
Evidence

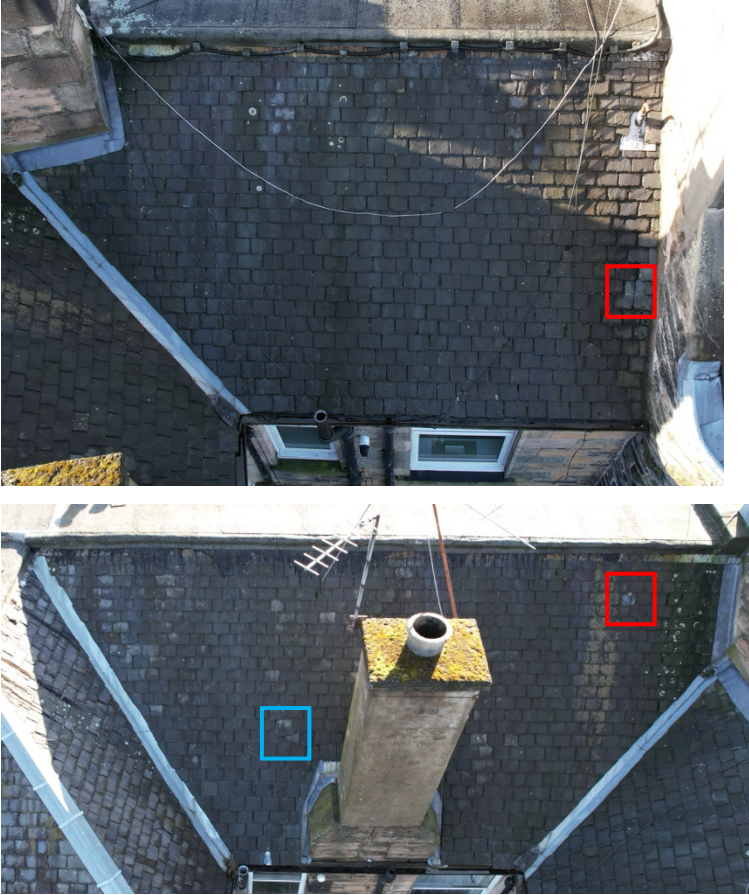
Section 6	
Repair Cat	2
Notes	Major: missing tiles (marked red), Minor: slipped tiles (marked blue).
Evidence

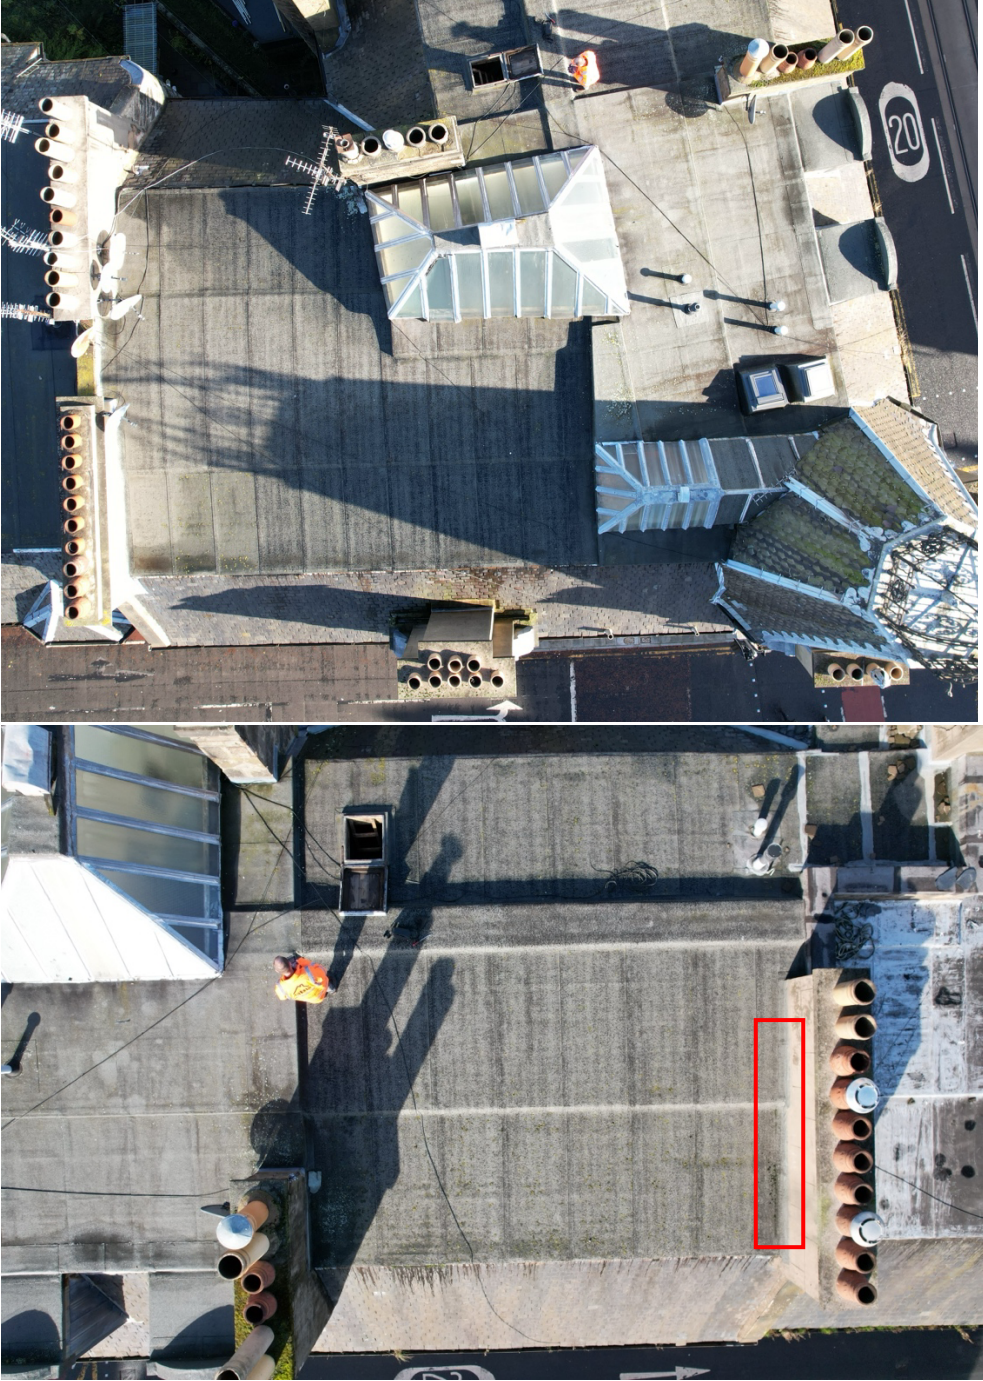
Section 7	
Repair Cat	1-2
Notes	Flat roof constructed of torch down felt with mineral topcoat. Physical inspection conducted. A few of the sheet edges were deboned slightly but still watertight with significant overlap. The worst being under the chimney (marked red). These should be monitored into the future.
Evidence

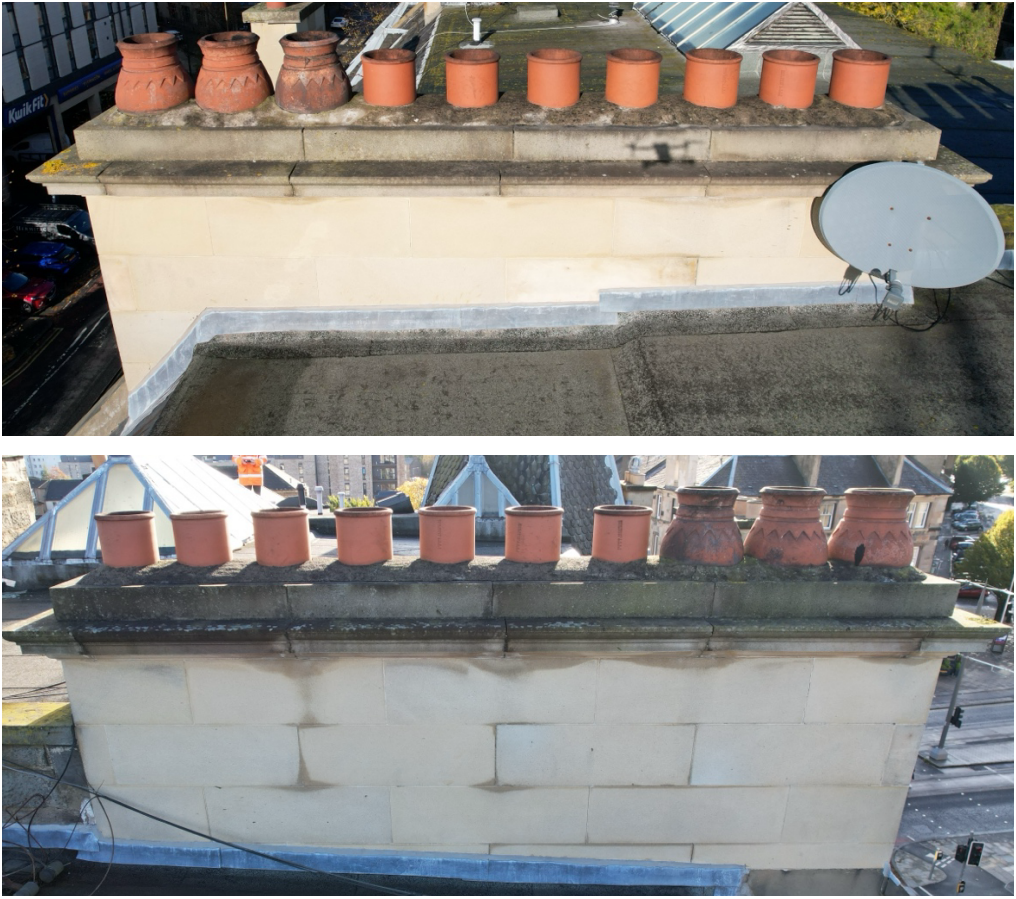
Chimney 1	
Repair Cat	1
Notes	Chimney pots, flaunching, crown, pointing and flashing are in excellent condition. No issues.
Evidence

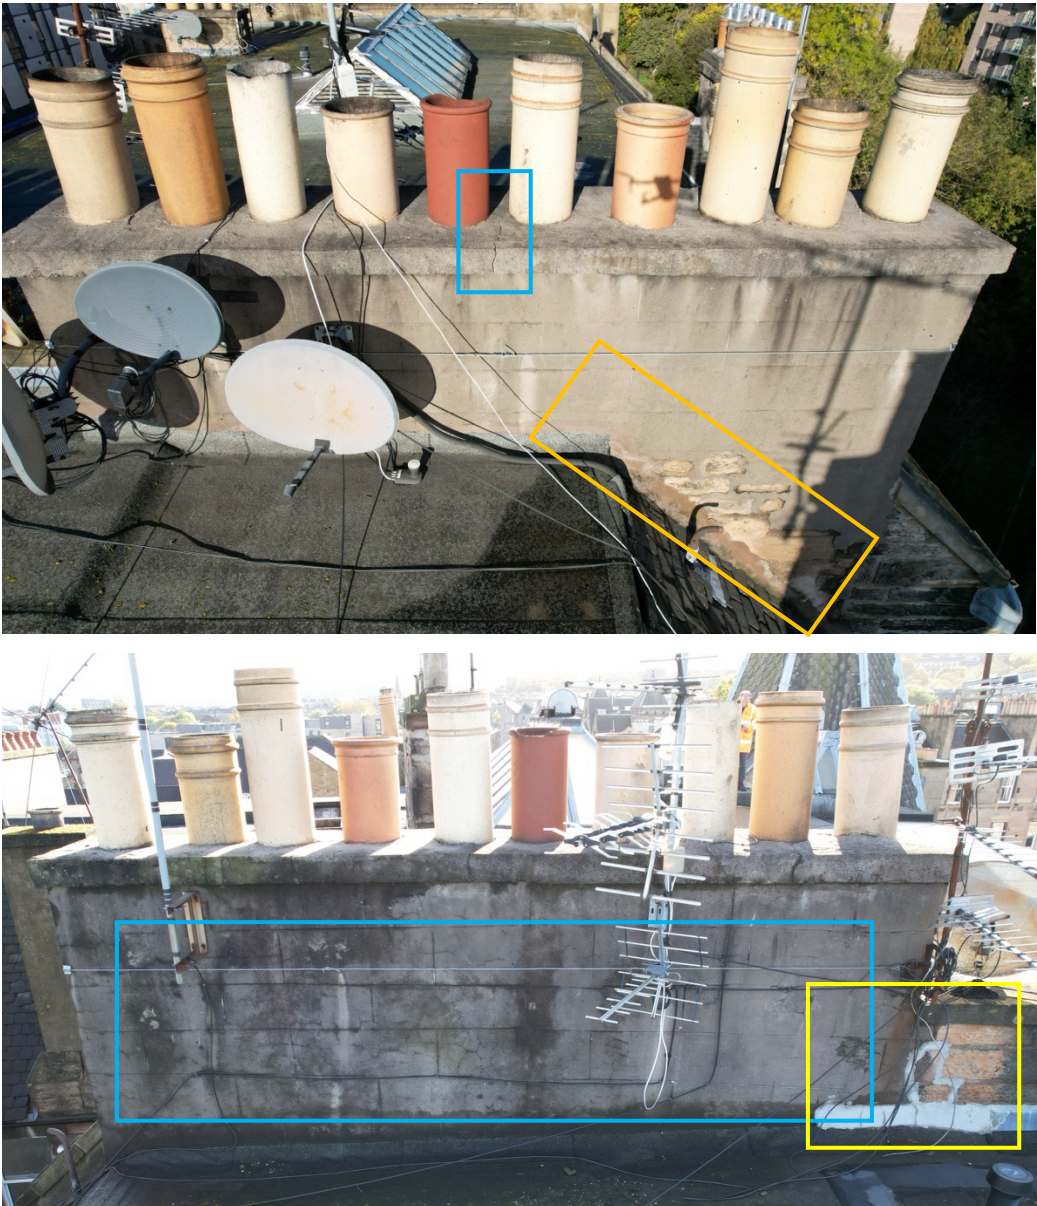
Chimney 2	
Repair Cat	2
Notes	Chimney pots, flaunching, crown, render and flashing are in reasonable condition. Minor: hairline cracks in crown and west side rendering (marked blue), evidence of repair (marked yellow). Missing rendering and cracked skew (marked orange).
Evidence

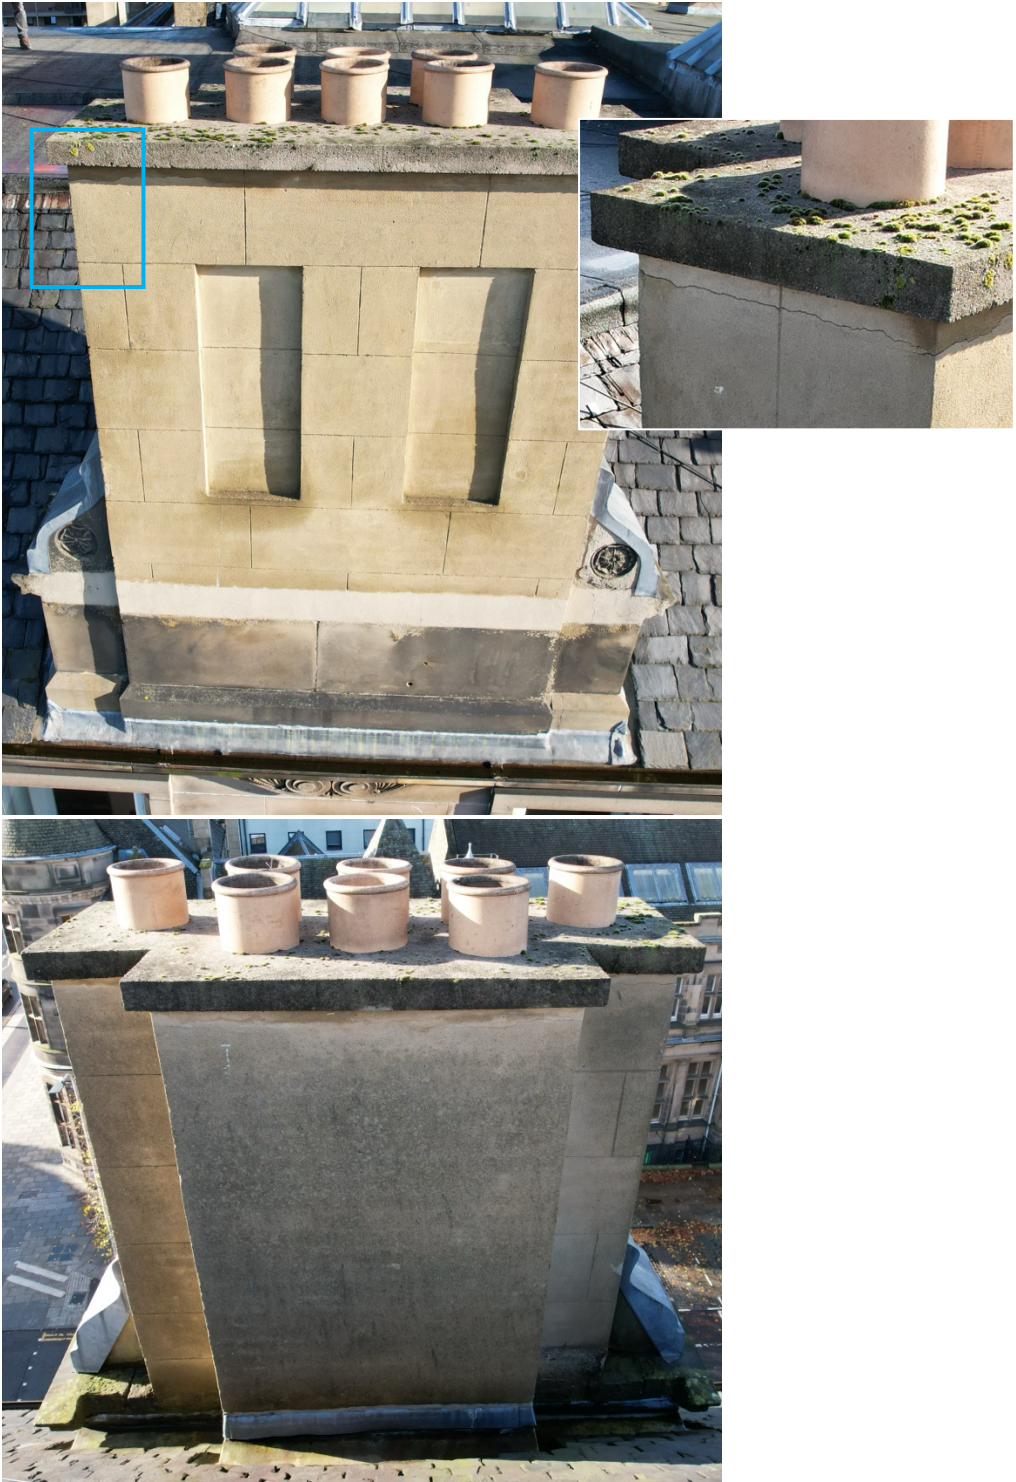
Chimney 3	
Repair Cat	1
Notes	Chimney pots, crown, rendering and flashing are in excellent condition. Minor: hairline crack in render under crown should be monitored (marked blue).
Evidence

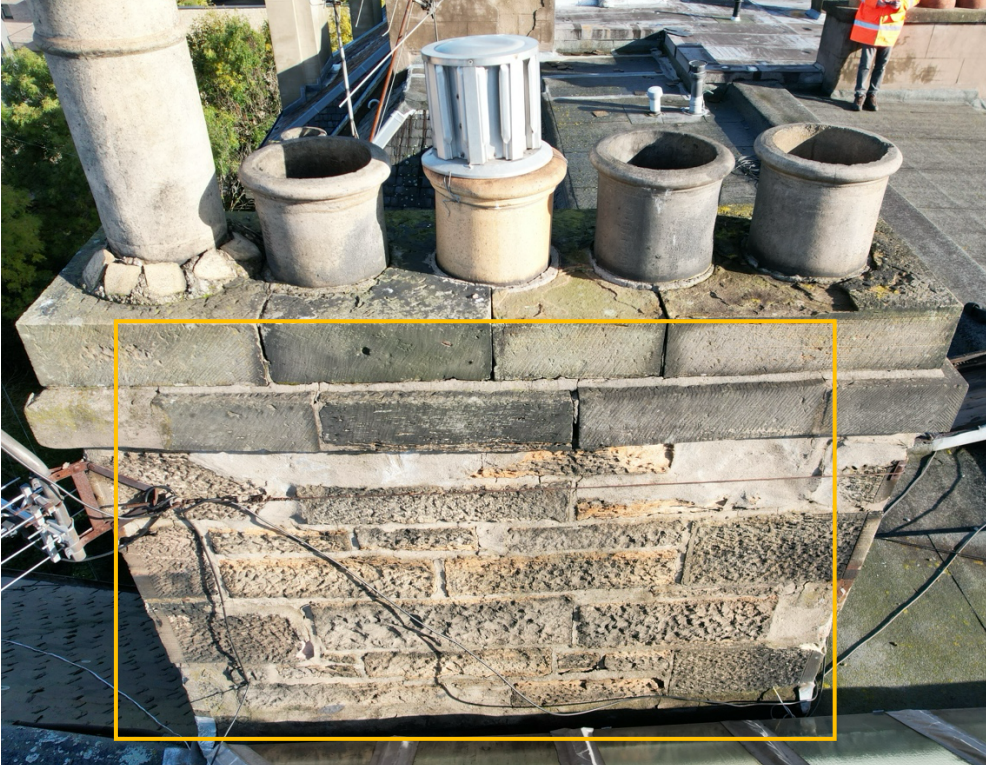
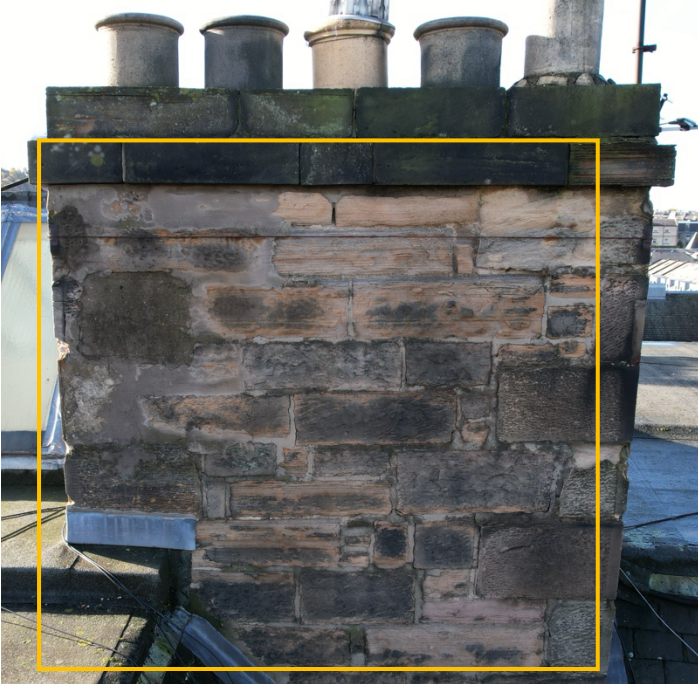
Chimney 4	
Repair Cat	2
Notes	Major: chimney requires repointing. There is extensive cracks and loss of pointing, spawling of existing stone. Rendering or redressing existing stonework is required.
Evidence

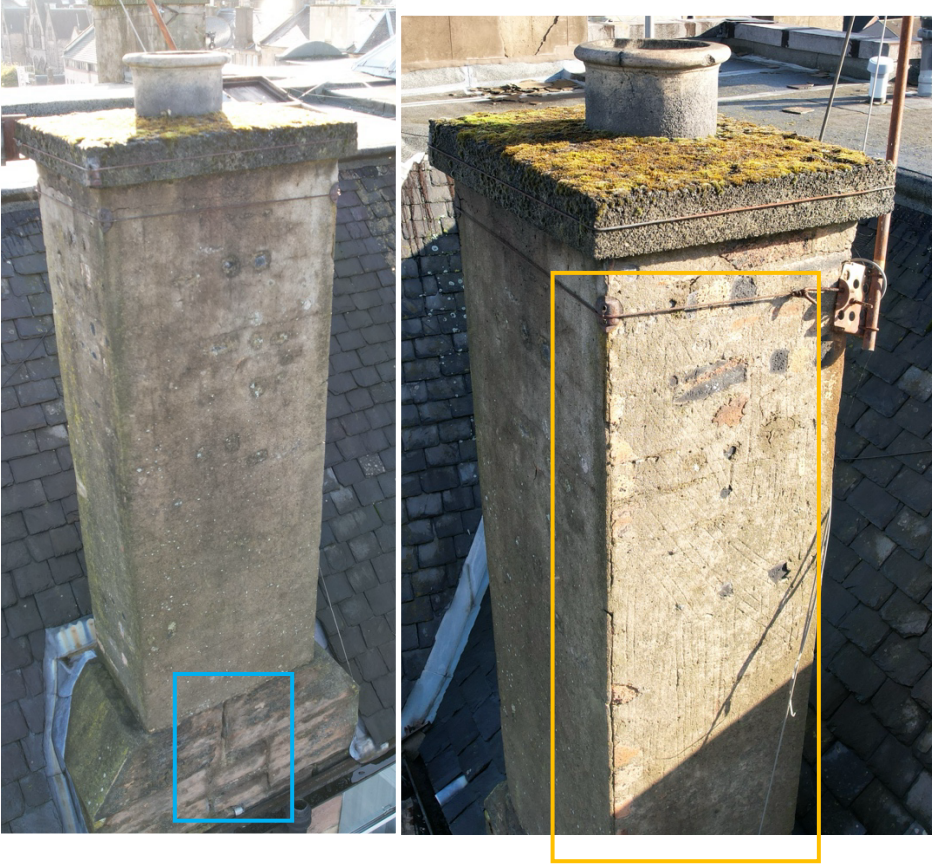
Chimney 5	
Repair Cat	1-2
Notes	<p>Chimney pots, crown, pointing and flashing are in reasonable condition. Brick with skim coat of cement render.</p> <p>Minor: missing pointing (marked blue). Render is flaking (marked orange).</p>
Evidence

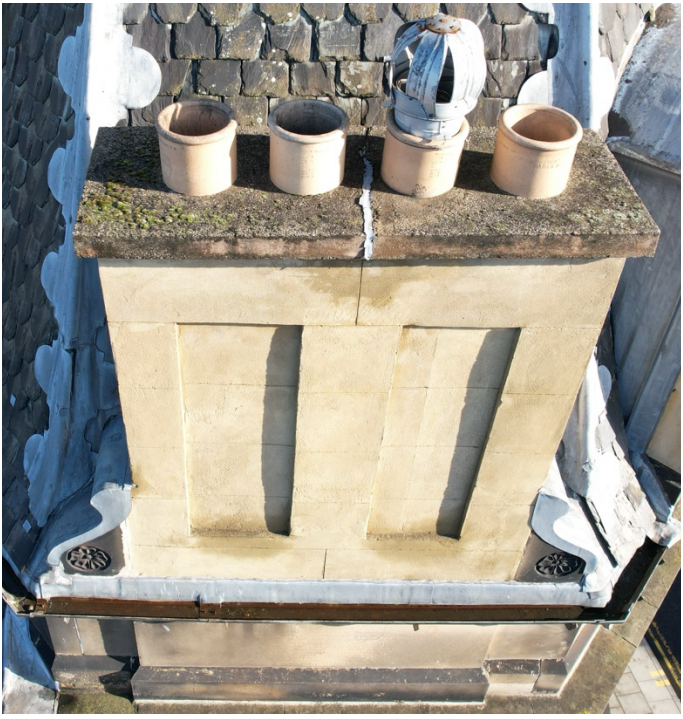
Chimney 6	
Repair Cat	1
Notes	Chimney pots, crown, pointing and flashing are in excellent condition. No issues.
Evidence

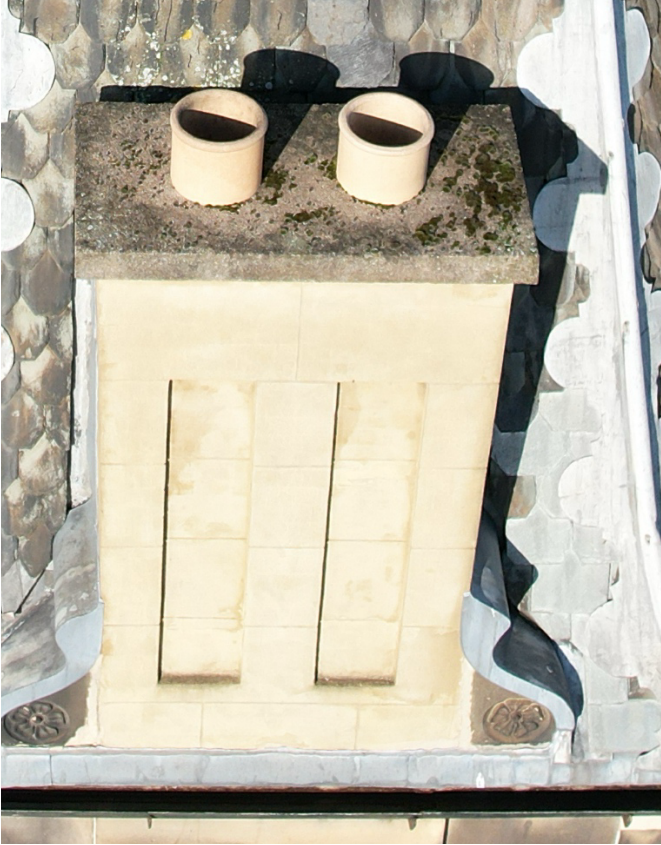
Chimney 7	
Repair Cat	1
Notes	Chimney pots, crown, pointing and flashing are in excellent condition. No issues.
Evidence

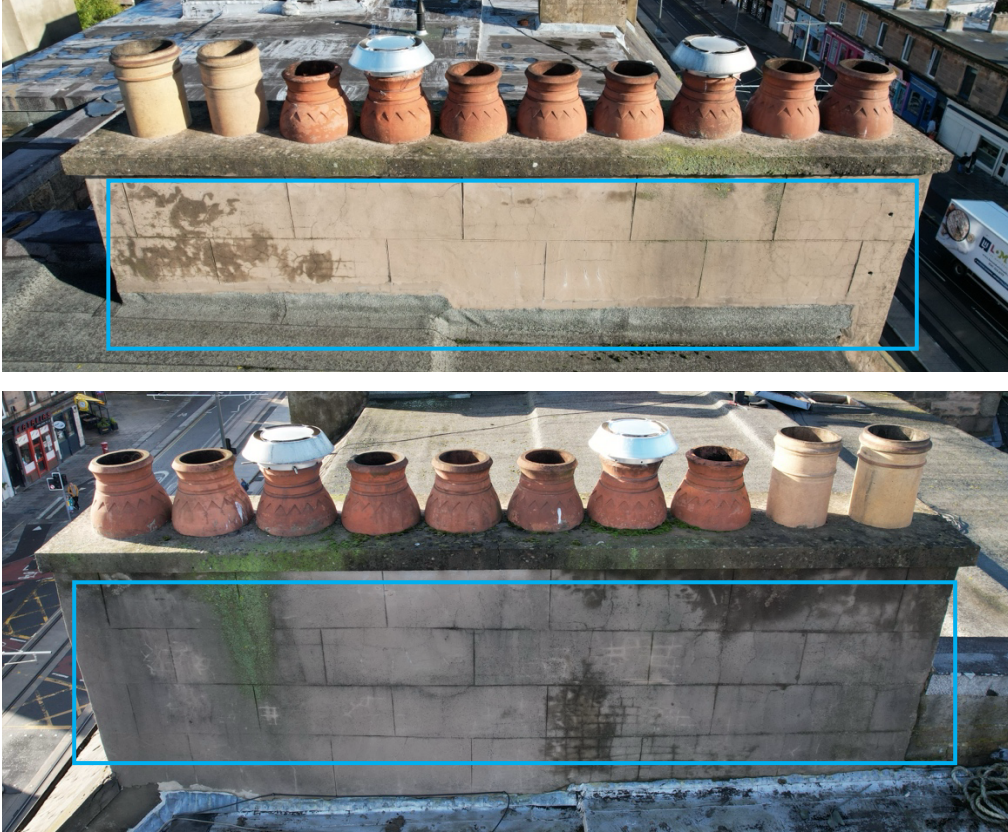
Chimney 9	
Repair Cat	1
Notes	Chimney pots, crown, pointing and flashing are in reasonable condition. Minor: hairline cracks in rendering to monitor into future.
Evidence
